NASA TN D-4881

NIMBUS II FLIGHT EVALUATION AND ENGINEERING REPORT, LAUNCH THROUGH ORBIT 5275

*Joseph J. McNaney and Bennie A. Palmer
General Electric Company*

*Ralph Shapiro
Goddard Space Flight Center*

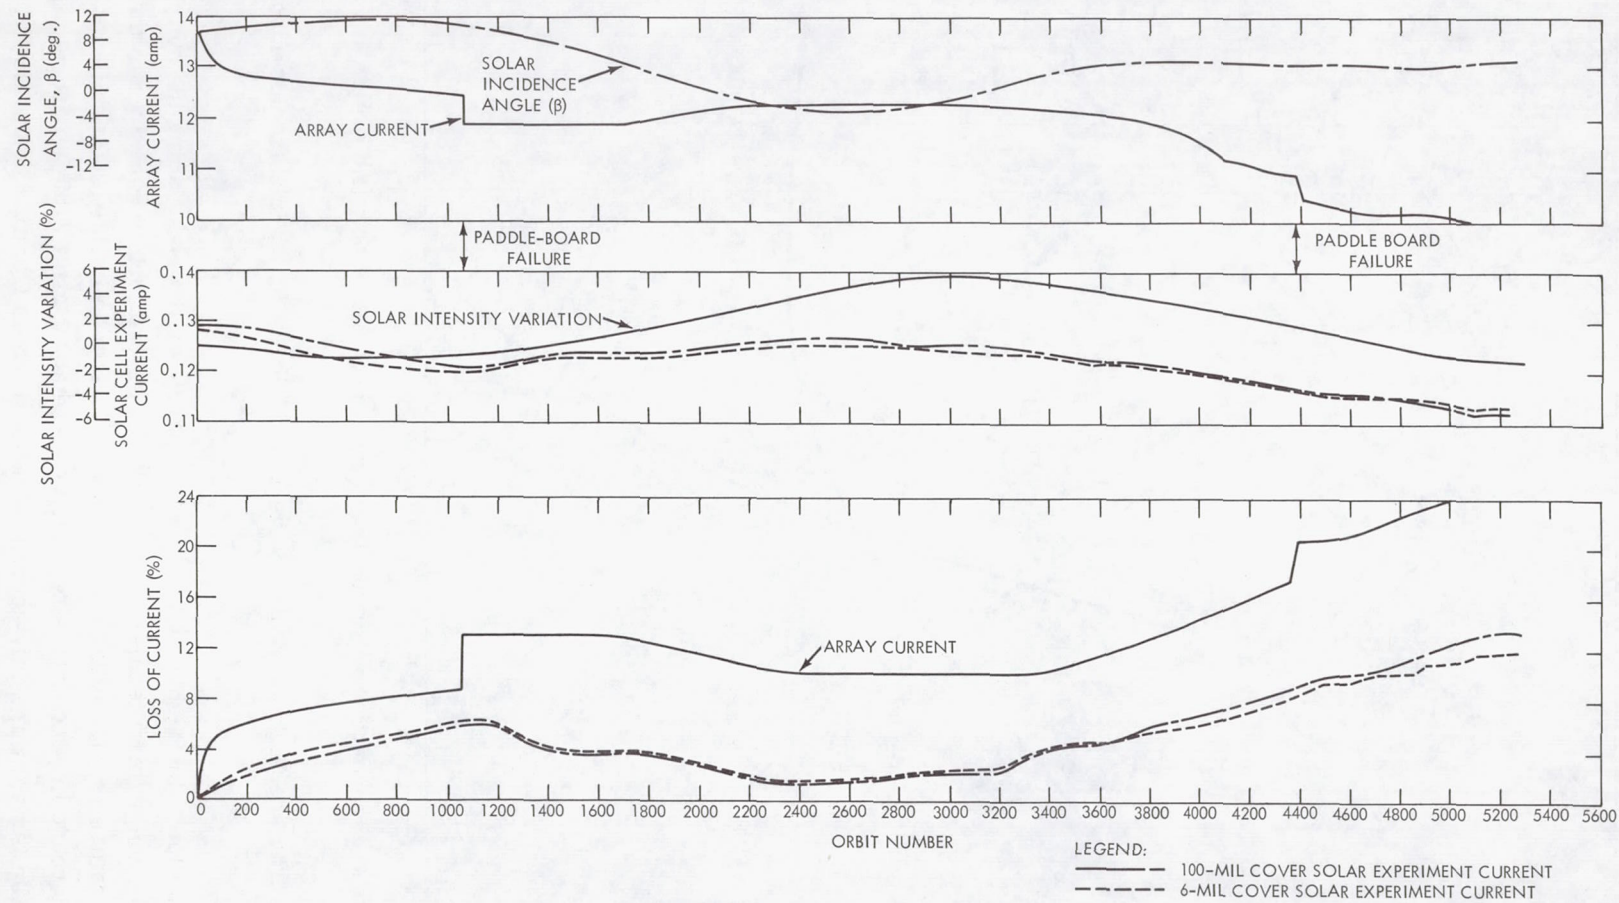
Figure 4-2—Array and solar-cell experiment current history.

During the early months of flight, the 9.75-degree solar incidence angle resulting from the spacecraft being launched early in the window (see Figure 4-2) caused the Controls Subsystem to shade a corner of one paddle before entering and after leaving the umbra. This caused a 1.4-ampere decrease in array output for 3 to 8 minutes.

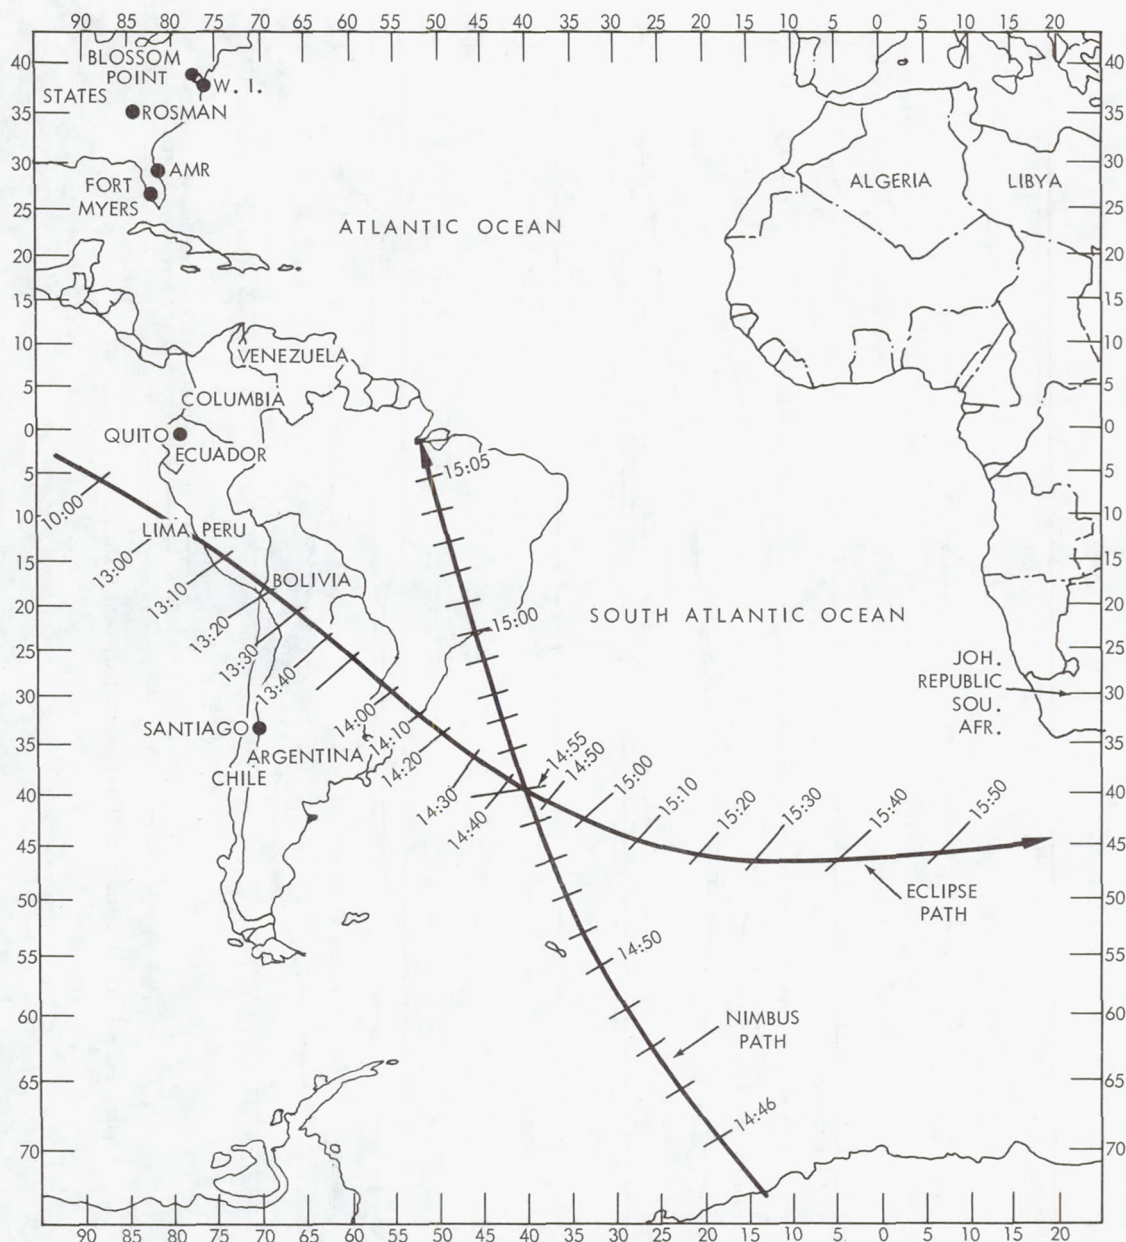
Figure 4-3—Intersection of Nimbus II orbit and path of solar eclipse (orbit 2413).

The spacecraft passed through three solar eclipses that affected the solar array output. The array output dropped approximately 2 amperes during orbits 68 and 4784, and during orbit 2413 (Figures 4-3 and 4-4), the array output dropped to zero for approximately 80 seconds. Paddle temperature dropped 10°C, and the unregulated bus voltage dropped from 30.4 to 26.5 volts, although there was sufficient sunlight on the paddle shaft sun sensors to prevent the paddles from being driven to the nighttime rest position (see Figure 5-19).

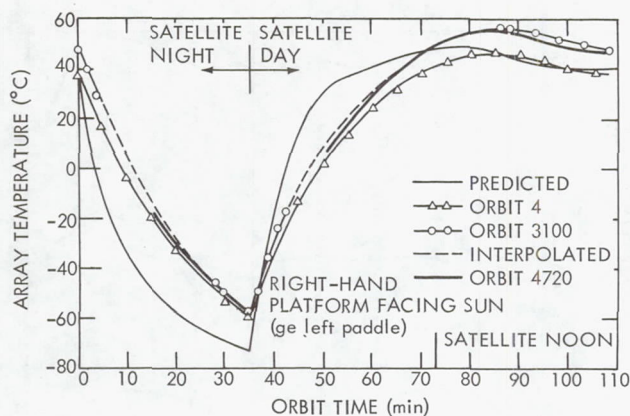
Figure 4-7—Solar platform temperature/time profile.

Figure 4-7 is a plot of the right-hand paddle (the paddle on the right facing the sun and in the velocity vector direction) orbital temperature profile for several orbits compared to the predicted values. The temperature remained relatively constant during the initial 1000 orbits and then increased with the increase in solar intensity, which peaked about orbit 3100 (6 percent higher). By orbit 4720, the paddle temperature only decreased a few degrees from the peak value at orbit 3100,

with the same sun intensity at launch. The decrease in solar conversion efficiency (down approximately 18 percent since launch) and a coating degradation contributed to the higher temperatures. The left-hand paddle exhibited the same profile except that the maximum temperature indicated is 10°C lower. A telemetry error is suspected and will be discussed later.

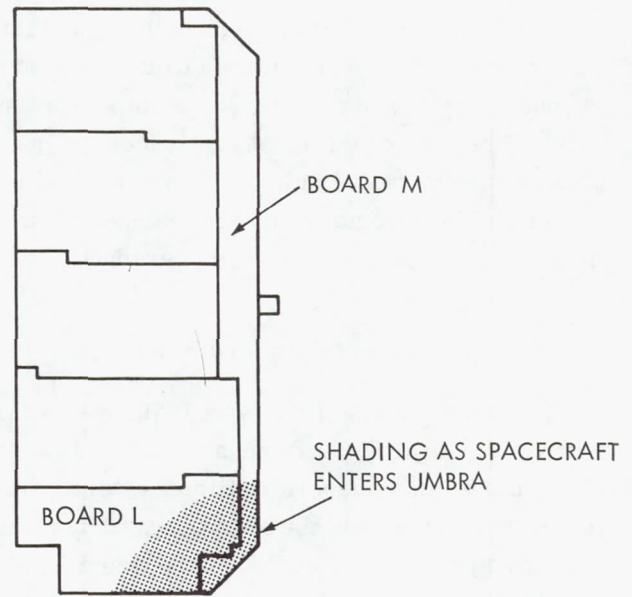
Figure 4-10—Shading of spacecraft left array (orbit 212U) during transition from satellite day to night.

A comparison of the solar array current output trailoff (before entering the umbra) before and after the drop in total output is shown in Figure 4-9. From the figure it can be seen that the telemetered value of array current (after the board failure) averaged approximately 700-milliamperes lower before shading and approximately 0.2 amperes lower during maximum shading than it did before the failure. Assuming that all cells delivered the same amount of current, board L (with 980 cells) and board M (with 582 cells) would provide 1.04 amperes and 0.645 amperes, respectively, based on the telemetered array current value of 12.2 amperes (sensor reading plus auxiliary load losses). The decrease (approximately 600 milliamperes) compares favorably with the 645 milliamperes that would be provided by board M. From Figure 4-9 it is noted that, since the failure, shading does not affect the total output until approximately 5.5 minutes before entering the umbra, whereas before the failure it affected the output up to 3 minutes earlier. The reason for this is that board M, because of shading, is affected normally before board L (because of the manner in which the shading occurs; see Figure 4-10). Therefore, if board M has failed, the dropoff would be delayed (Figure 4-9).

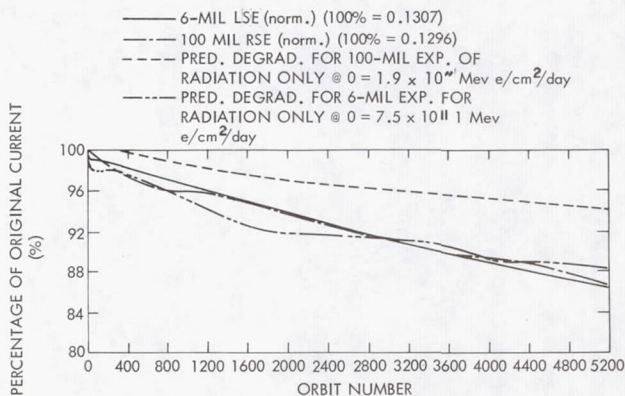
Figure 4-24—Current loss versus orbit for solar-cell experiments.

Figure 4-24 is a plot of the normalized percentage of current loss versus orbit for both experiments. The data points for these plots were taken at the same paddle position at all times. This permitted normalizing for sun angle and sun intensity seasonal variations, but introduced a possible error caused by temperature variations at that paddle position, ranging from 16° to 20°C.

Both experiments, in the early orbits, showed a smaller loss caused by ultraviolet damage than the solar array indicated. The degradation at orbit 5200 was near the predicted

value at a flux level of 7.5×10^{11} e/cm²/day (3 to 4 percent for first 100 hours predicted) predicted for the 6-mil experiment, which has the same characteristics as the actual array cells. The 100-mil experiment had a much higher degradation than anticipated. The extra thick coverglass on this experiment yielded a calculated flux rate of 1.9×10^{11} e/cm²/day on the actual cell. A 4-percent degradation was predicted at orbit 3100, yet 10 percent was actually observed.

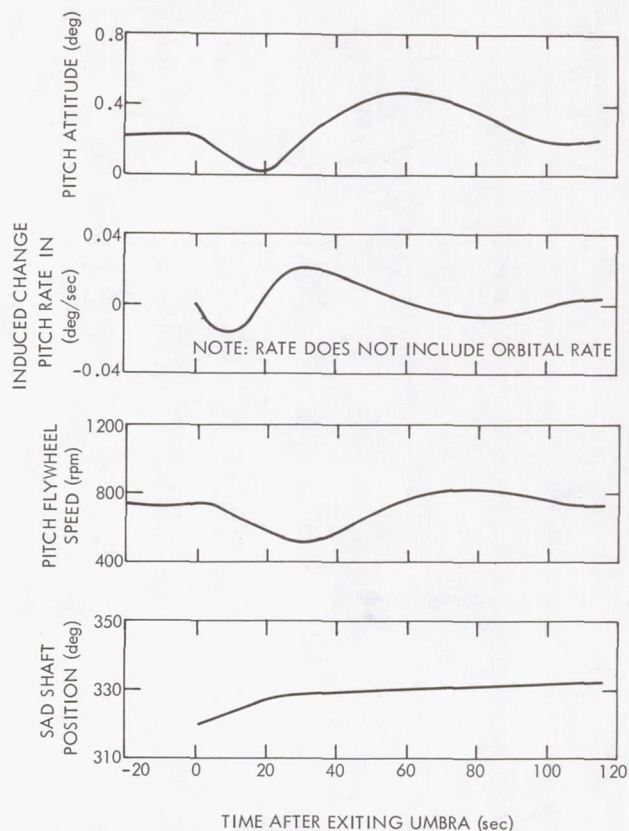
Figure 5-11—Pitch stabilization control characteristics during transition from satellite night to satellite day (orbit 60).

torqued the spacecraft in a positive sense that, combined with array deceleration, caused an overshoot of approximately 0.24 degree beyond the initial attitude of 0.2 degree. The perturbation was subsequently damped, and the pitch attitude returned to its initial condition of 0.2 degree within 2 minutes. The pitch attitude error was approximately 0.2 degree initially (Figure 5-11) because during the early orbits, a positive pitch disturbance torque was acting on the spacecraft thus effecting a positive pitch offset error. In later orbits, the pitch disturbance torque became negative and resulted in a small negative average pitch error. However, the direction and relative magnitudes of the error induced during the satellite night-to-day transition remained the same.

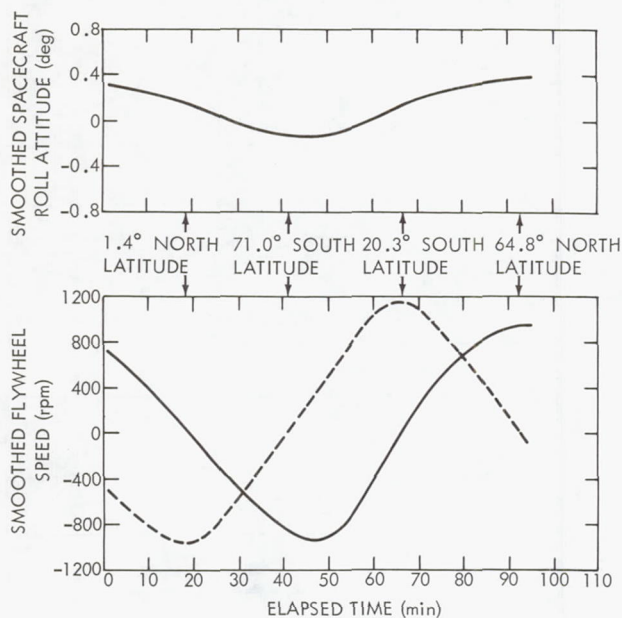
Figure 5-12—Roll-yaw momentum exchange showing induced mean roll attitude error (orbit 450).

During the Nimbus II flight there has been a continuing interchange of momentum between the roll and yaw flywheels. The spacecraft has rotated at a constant rate about the pitch axis and has completed one revolution each orbit. With no appreciable torques acting on the spacecraft, the total system momentum vector is fixed in inertial space. Therefore, the component of system momentum lying in the orbit plane must be continually interchanged between the yaw and roll flywheels. This phenomenon is shown in Figure 5-12. The interchange is brought about as the pitch

rate induces a gyroscopic moment in the yaw and/or roll flywheels proportional to their respective rotational speeds. This moment is applied to the opposite axis. For example, the yaw flywheel gyroscopic moment induces motion about the roll axis, which increases the roll attitude reference error and the roll flywheel speed. The imparted roll rate is sensed by the yaw gyro, which in turn decreases the yaw flywheel speed. This continuing effect is such that during a single orbit, the yaw and roll flywheel speeds respond in a sinusoidal manner, 90 degrees out of phase with each other (Figure 5-12). The maximum roll flywheel momentum periodically stored each orbit was greater than predicted. This increased momentum has been attributed to a disturbance torque caused by the interaction of the magnetic force field of the spacecraft.

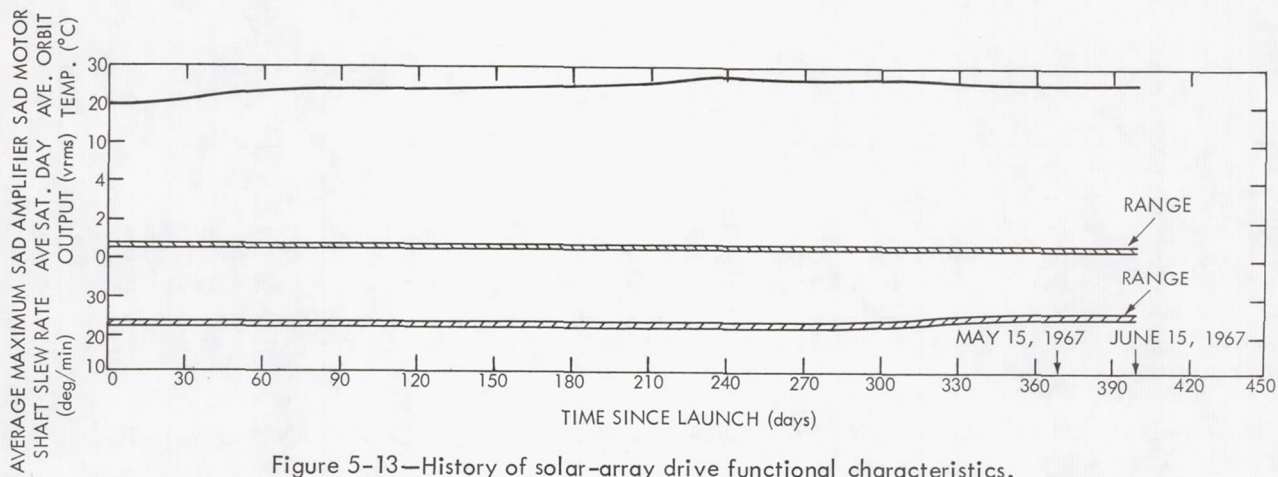
Figure 5-13—History of solar-array drive functional characteristics.

Figure 5-13 presents the history of the SAD functions. During the first month of flight, the solar array was observed to advance 0.5 to 1.0 degree after settling in its night rest position. This was attributed to noise on the 400-Hz power supply used by the SAD and flywheel motors. This phenomenon is no longer observed.

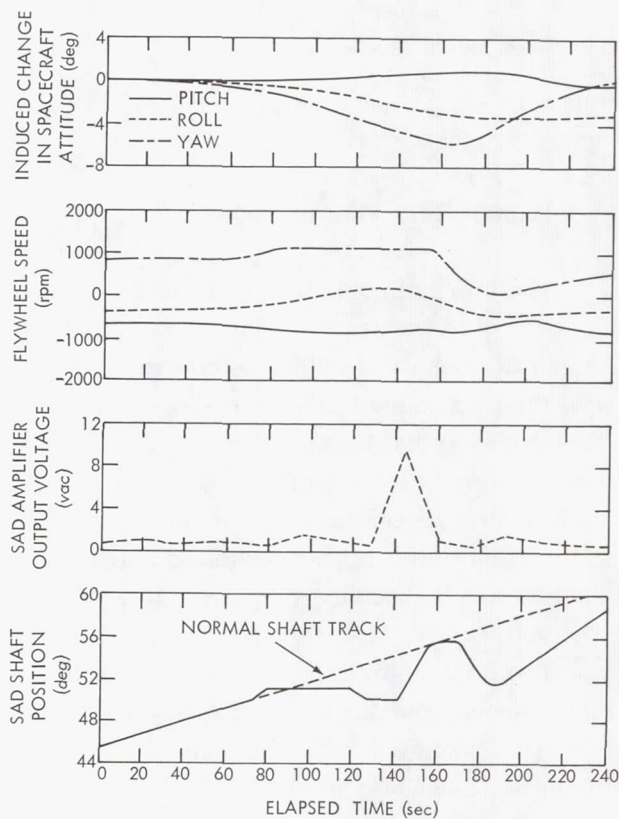
Figure 5-14—Solar-array drive reversal characteristics correlated with change in spacecraft attitude (orbit 1590).

Also, in the early parts of flight, the high solar incidence angle β , when combined with negative yaw error caused deviations in the SAD shaft tracking (Figure 5-14). A review of the SAD performance showed that the drive occasionally slowed down and/or reversed for 1 to 2 minutes, at which time deviations from nominal approached 5 degrees of tracking error. These deviations occurred between the earth day (0 degrees) and high noon (90 degrees) orbit position and were accompanied by large excursions of the roll and yaw flywheels because of cold cloud patterns. These deviations in shaft tracking, as noted from flight data, occurred only when the vehicle roll and yaw positions were perturbed by a cloud pattern. Therefore, it was concluded that the cause of the deviations was a negative yaw error, adding to the existing 10-degree orbit plane misalignment, resulting in uneven shading of the solar array sun sensor. This problem ceased when the β angle became lower. If the orbit plane solar β angle had become much larger, it is assumed that this anomaly would have occurred more often.

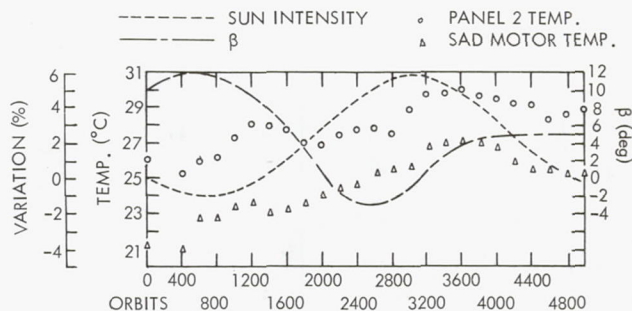
Figure 5-16—SAD motor temperature versus panel no. 2 temperature.

The SAD motor temperature has varied with the temperature of Control Housing Panel No. 2 since launch, running approximately 3°C lower than Panel No. 2 (Figure 5-16). Since Panel No. 2 is warmer than the SAD motor, it is assumed that the SAD motor is possibly absorbing heat from Panel No. 2 because of the thermally conductive heat path that exists between the two. In this case, the SAD motor would probably run at a lower temperature if it were not "heat-sinked" to Panel No. 2. This situation has caused no detrimental effects since the temperature of the SAD motor is well within the specified limits, averaging $24 \pm 3^\circ\text{C}$ for the 13-month period. Since the thermistor for Panel No. 2 is located at the opposite end from the heat sink, the temperature indicated may not be

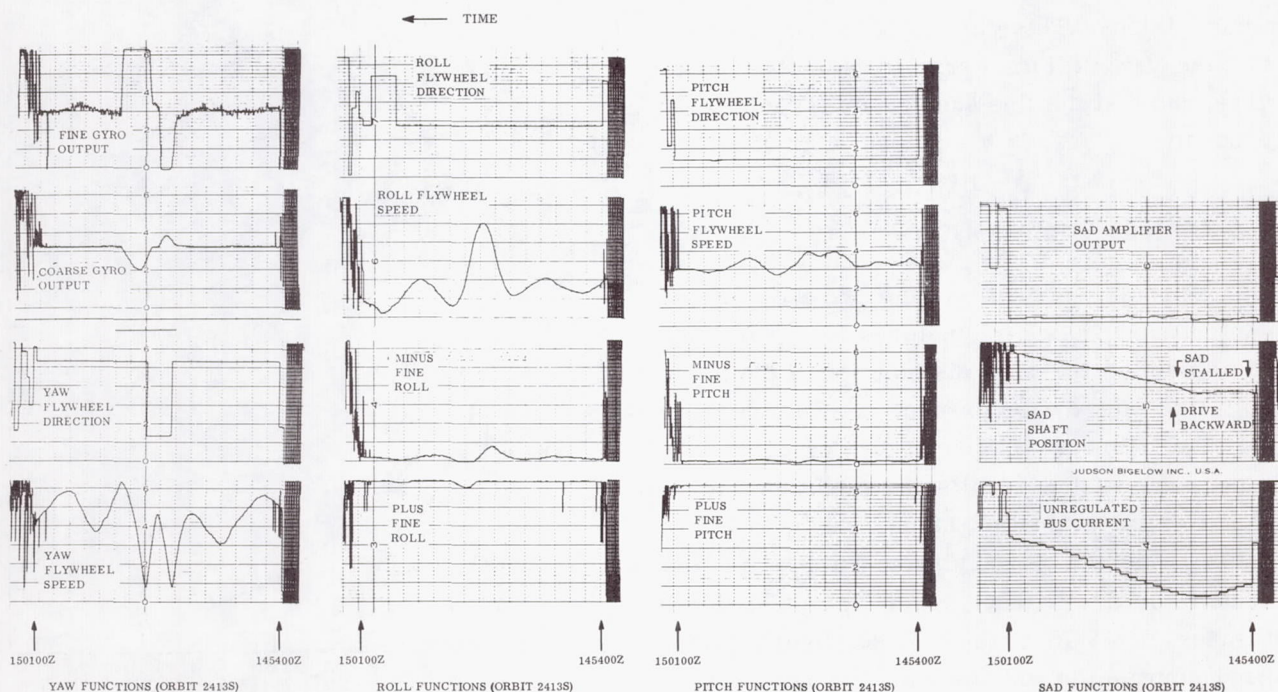
Figure 5-18—Control function performance during eclipse (orbit 2413S).

However, during orbit 2413, the spacecraft passed through the region of a partial eclipse. Figure 5-18 shows the performance of various control functions during the eclipse. The spacecraft entered the eclipse at approximately 1445Z and exited at approximately 1502Z. The PCM data were received at Santiago, Chile, from 1454Z to 1501Z. Therefore, the spacecraft was in the eclipse area approximately 9 minutes before the receipt of PCM data.

At the beginning of the data the roll and yaw flywheels and the gyro were fairly quiet, the SAD motor was stalled at an orbital position of 65 degrees, and the unregulated bus current was zero (0.9 TMV \Rightarrow Telemetry Volt). Two minutes after the start of data (1456Z), the SAD motor resumed normal sun tracking, and unregulated bus current started to increase back to its normal value for daytime operation. The stalled condition of the SAD was caused by the reduced sun sensor amplifier output, which was still sufficient to override the feedback pot voltage, thus preventing the SAD from driving to the array sunrise position; however, it was not sufficient to perform normal sun tracking. The SAD did drive backwards approximately 4 degrees toward the sunrise position as the spacecraft passed through the area of least sun illumination and then drove rapidly forward for approximately 45 seconds just before the resumption of normal sun tracking.

At 1458Z, the spacecraft underwent a severe perturbation lasting almost 2 minutes. This disturbance is shown by the fine gyro off-scale readings and the increased activity of the roll and yaw

flywheels. Two factors indicate that this was a normal cold cloud-induced disturbance and was not caused by the eclipse:

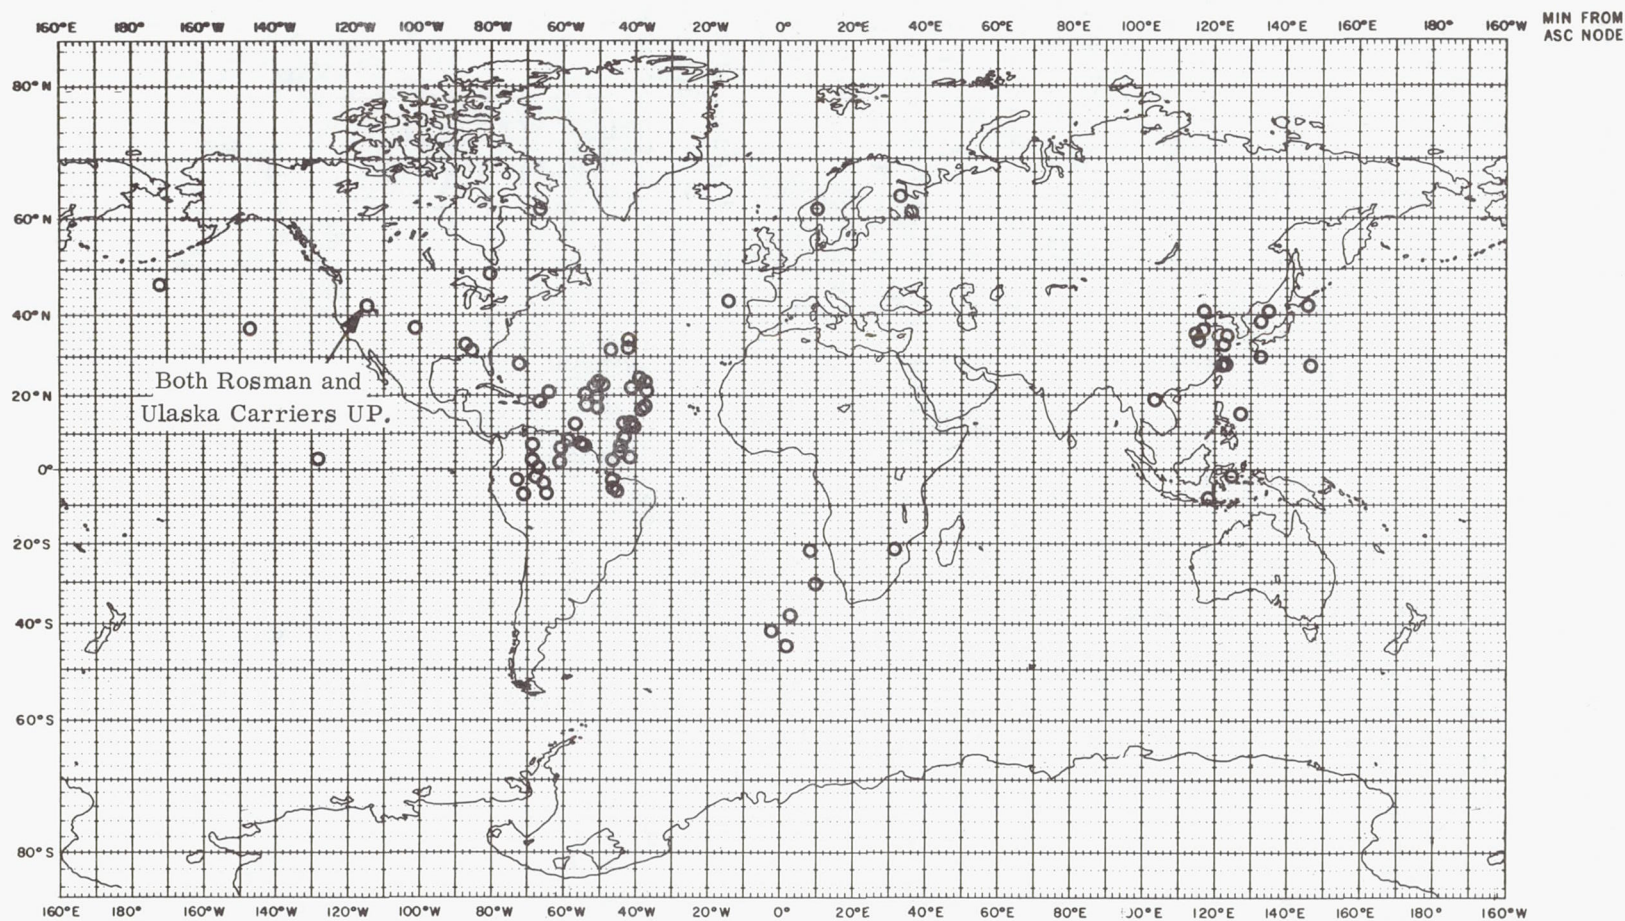
While A-stored data were available during the first 2 months of operation, a plot was maintained of the geographical locations of the unencoded command executions (Figure 7-4). Since many of these unencoded commands were executed in the general vicinity of northern South America, a standard operational procedure was developed whereby the STADAN stations at Quito, Ecuador; Santiago, Chile; and Rosman, North Carolina radiated an unmodulated carrier whenever the spacecraft was in range of these stations. There was no instance of unencoded command execution with any single station transmitting an unmodulated carrier. However, to avoid unwanted command executions caused by beat frequencies between two carriers, a 30-second interval was provided between the transmission end time for one station and the transmission start time for the next station. There were several instances of unencoded command executions during these 30-second intervals. This procedure was begun May 20 and terminated November 15, 1966. A summary of observed unencoded command execution is presented in Table 7-1.

Figure 7-4—Geographic locations of unencoded command executions.

This record may be considered incomplete because only real-time data have been available since the PCM recorder failure in orbit 949. In the last several months of operation, it has been standard procedure to command the spacecraft using the redundant FM demodulator; consequently, only U960 commands have been observed.

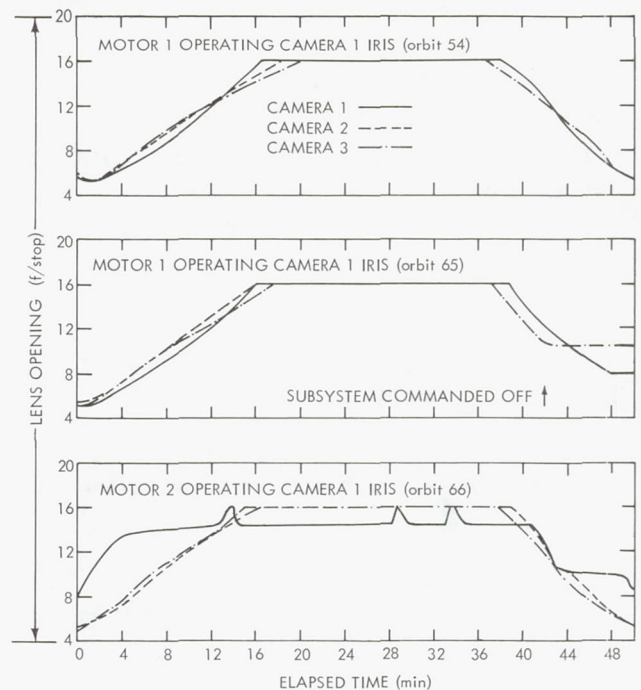
The normal practice is to alternate iris drive motors each day; however no. 2 iris motor of Camera 1 failed to position the iris properly. Telemetry indicated that the iris drive motor failed to perform properly when first activated after launch. Figure 9-4 is a comparison of the performance of the various iris motors of all three cameras. During orbits 54 and 65, the no. 1 iris motor of Camera 1 was powered; during orbit 66, the no. 2 iris motor was powered. Figure 9-4 shows that no. 2 iris motor of Camera 1 failed to maintain proper iris positioning. Since orbit 98, the no. 1 iris motor has been used exclusively for Camera 1 and has shown no evidence of performance degradation.

Figure 9-4—AVCS camera no. 1 IRIS drive history.

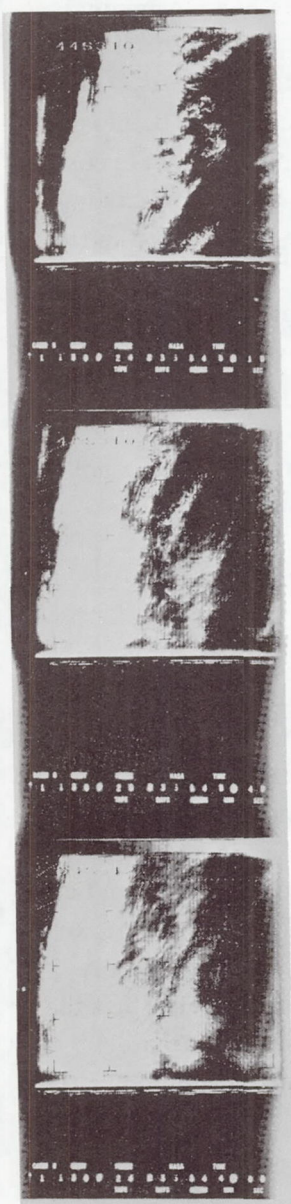
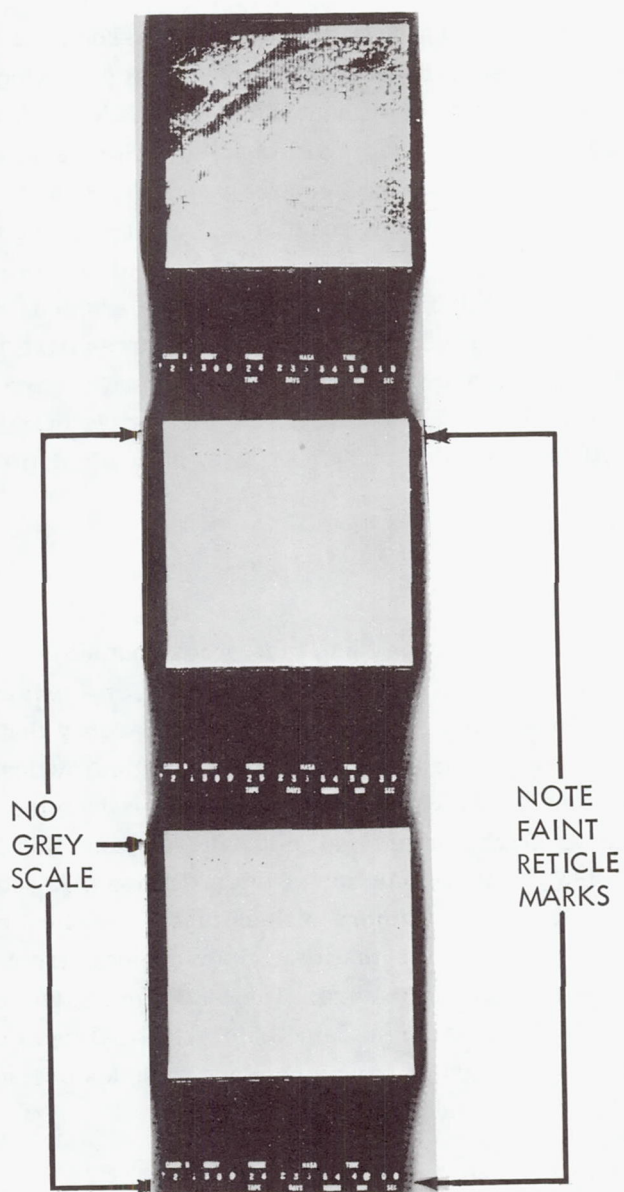
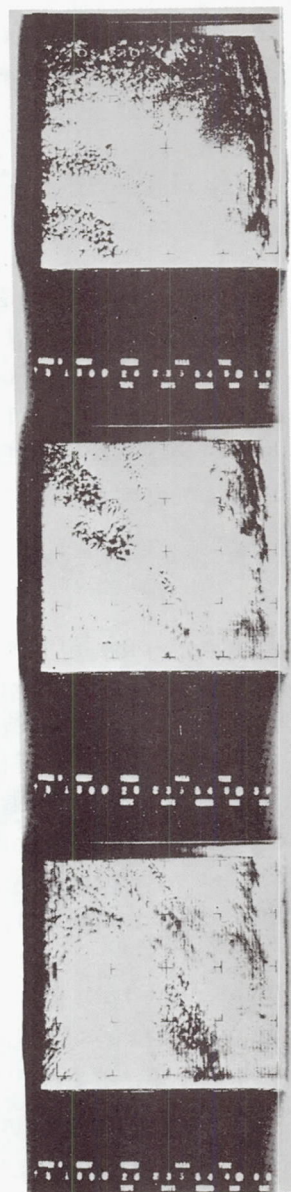
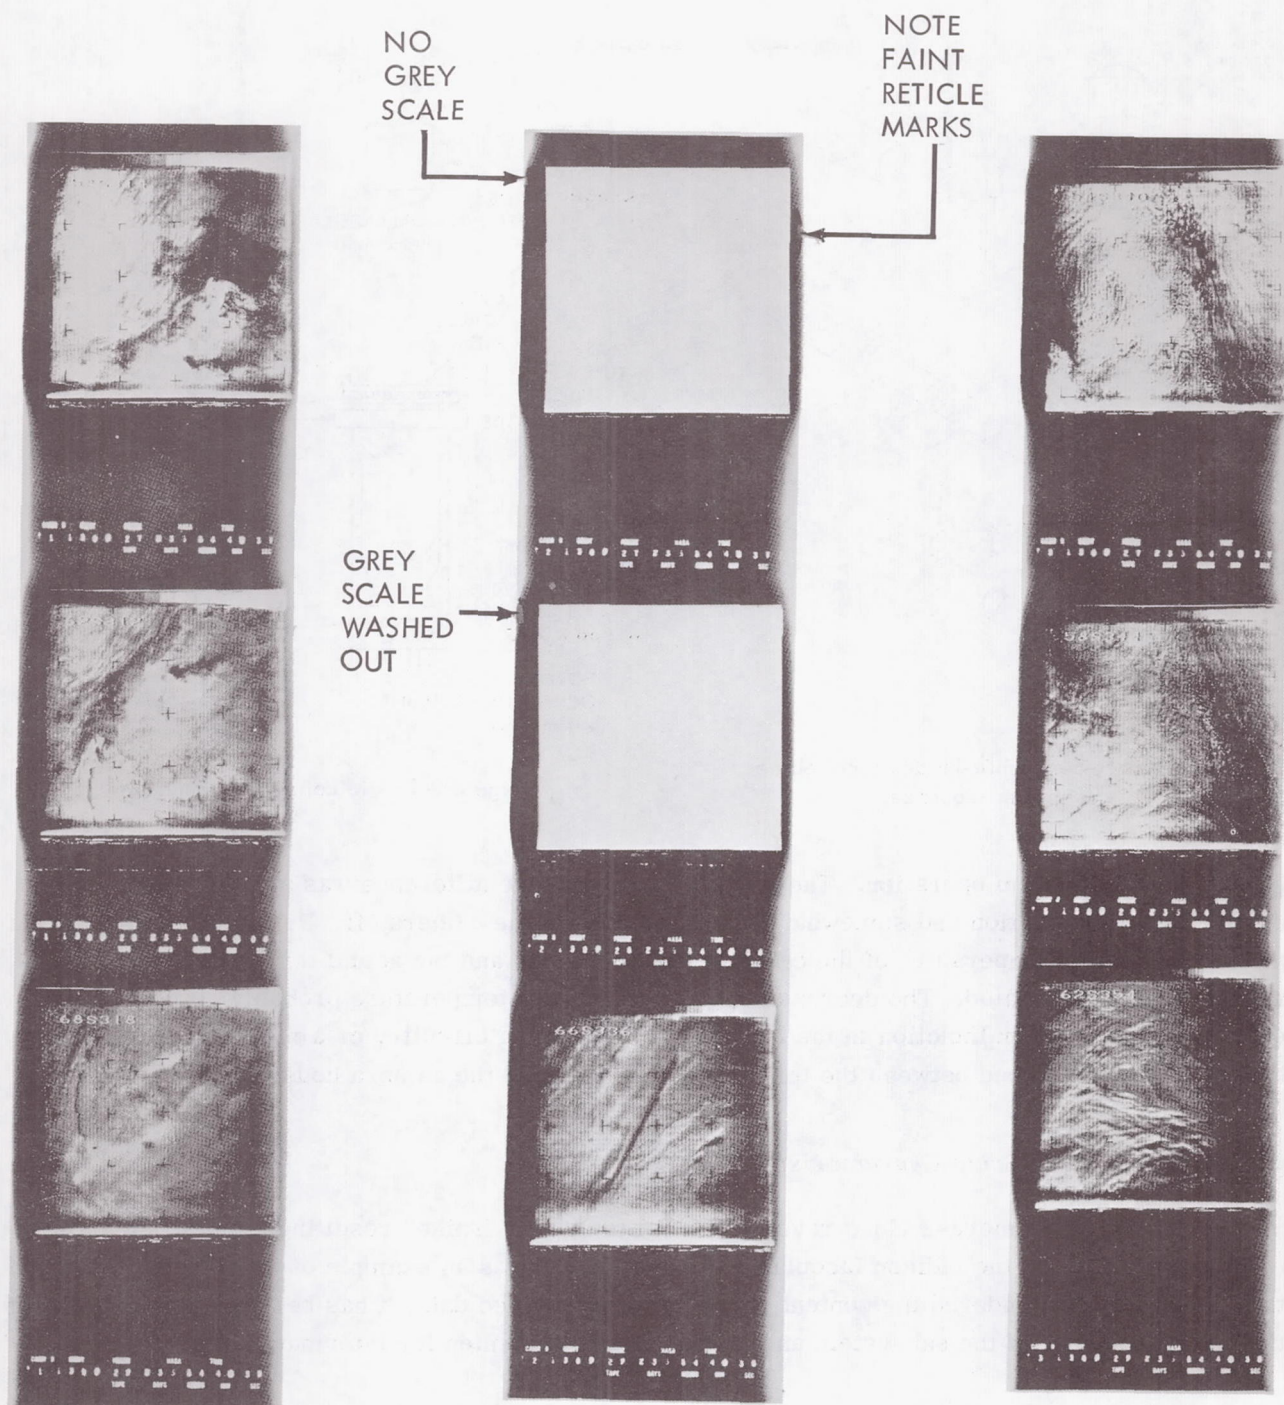
During interrogation 1309U, four frames (27 through 24) of video from Camera 2 were almost totally "washed out" (Figure 9-5). The only distinguishable features were faint traces of the fiducial marks. In addition, frame 27 exhibited faint traces of the bottom fiducial line and grey scale. Camera 1 and Camera 3 video remained normal throughout this period.

At the time of exposure of frame 28 in orbit 1309, shutter blade no. 1 of Camera 2 apparently failed to release at the prescribed time. The nature of the malfunction was either mechanical (binding, friction, seizure) or electrical (malfunction in the associated solenoid-enable circuitry resulting in continuous solenoid energization). This condition continued for four frames, whereupon normal operation was resumed. Movement of shutter blade no. 2 was thought to be normal, but shutter blade no. 1 did not shut as rapidly as required. This resulted in nonuniform exposure of the vidicon, the lower part of the vidicon faceplate receiving less incident light. This anomaly, seen as progressive in nature (Figure 9-5), resulted in the appearance of the reticle marks (though very faint) in the area of the first picture (frame 28) closest to the bottom of the vidicon. The bottom edge of the vidicon (Figure 9-6) contains the grey scale which, when processed, appears at the top of the processed print. Thus, the reticles on the lower part of the vidicon appear in the upper part of the processed print, and vice-versa. As time progressed, the reticle marks and grey scale vanished (frames 26 and 27). By frame 25, the reticle marks at the bottom of the vidicon were again visible. After a duration of four frames, the malfunction vanished and has not been observed since.

Figure 9-5— AVCS photographs showing washedout frames of camera no.2.

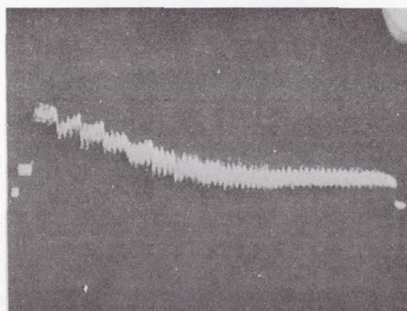
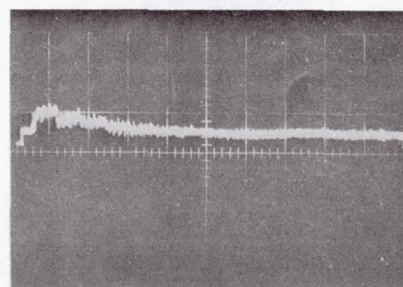
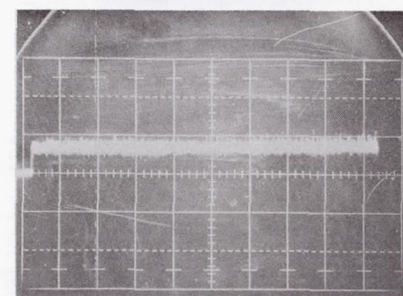
SCOPE PRESENTATION OF UNDEREXPOSED GREY SCALE,
RESULTING IN GREY SCALE OF APPROXIMATELY
1/2-NORMAL AMPLITUDE

SCOPE PRESENTATION SHOWING ABSENCE OF
GREY SCALE DEFLECTION

(c) ORBIT 3520, FLASH TUBE
FAILS TO TRIGGER

Figure 9-8—Camera 3 video displays (vertical scale: 0.5 v/cm; horizontal deflection: 5 msec/cm).

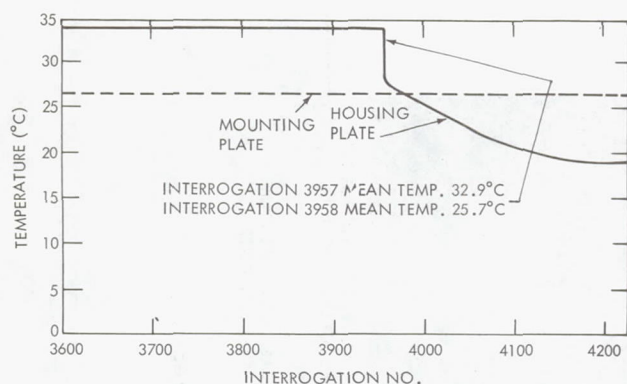
The telemetered value of the Camera-2 housing temperature indicated a decrease from 32.9°C (interrogation 3957, mean temperature) to 25.7°C (interrogation 3958U mean temperature) and subsequently to 18.3°C (interrogation 4164U mean temperature, Figure 9-9). The temperature of the Camera 2 mounting plate, which provides thermal conduction from Camera 2 to the H-frame, did not reflect a corresponding temperature decrease but continued to exhibit a nominal orbit profile of $25.7 \pm 1.3^\circ\text{C}$. The A-scope presentation of the camera grey scale did not show a decrease in camera temperature.

The temperature of the AVCS Camera 2 was approximately 32°C during system operation. The temperature difference between the camera and the mounting plate remained a constant 6°C

irrespective of system operation. The expected temperature difference was approximately 2°C during camera operation and somewhat less than 2°C with the camera off. Hence, it was suspected that the indicated temperature of the camera was erroneous and the actual temperature was probably lower than indicated. The decrease of the telemetered temperature probably resulted from either an electrical malfunction in the telemetry conditioning circuitry or a mechanical degradation of the thermal bond between the temperature sensor and the camera housing.

Figure 9-9—Camera 2 housing and mounting plate temperature.

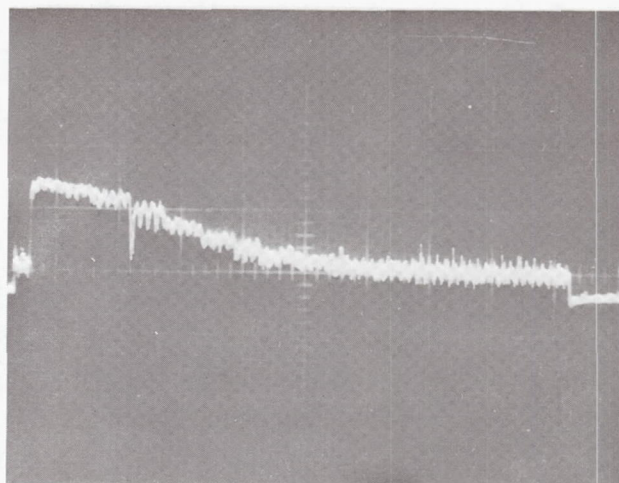
Evaluation of Camera-2 video revealed a characteristic "spike" resulting from a flaw in the etched grey scale on the vidicon faceplate. Figure 9-10 shows an example of this defect. Although this defect has not hindered the content of the subsystem video data, it has been present throughout the operational life of the subsystem and is, therefore, presented for information purposes.

Figure 9-10—Oscilloscope display photographs exhibiting AVCS camera 2 grey scale "spike."

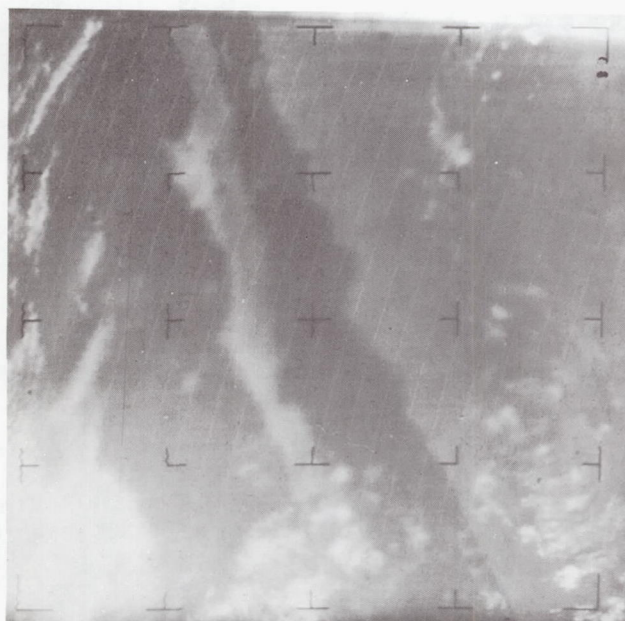
The Camera-1 video focus deteriorated during the 11th month in orbit (Figure 9-11). The fiducial marks, which are etched on the faceplate of the vidicon, have remained in focus, and the related telemetry data given in Table 9-2 do not reveal any anomalous conditions. The problem,

Figure 9-11—AVCS photograph showing loss-of-focus effect on the video of camera 1 (orbit 5154).

On occasions, faint AVCS chopper interference of approximately 3.3 kHz was present in the video of Camera 1 only (Figures 9-11 and 9-20). The origin of this interference is the high-voltage converter circuitry in the AVCS camera electronics. This type of interference was rather rare and did not seriously degrade the overall video quality.

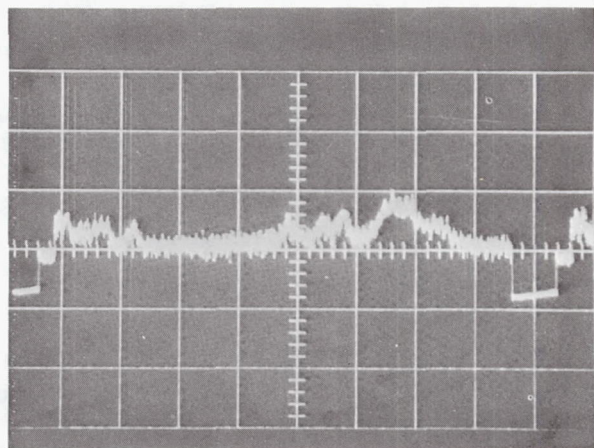
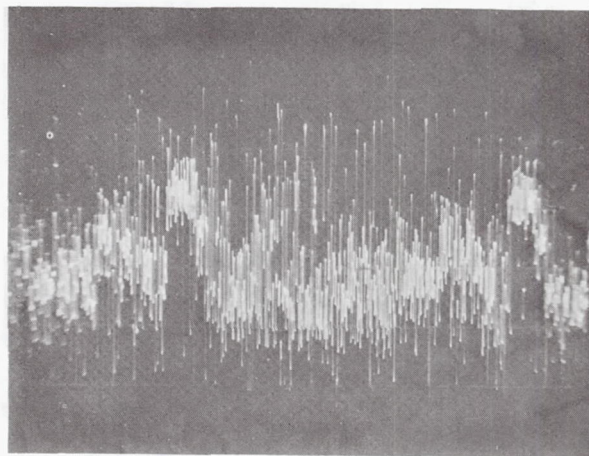
During recorder playback, prelaunch through failure, video data at times were exhibited between "triplets" because of the incomplete erasure of the recording tape (Figure 9-12). It should be noted that the quality of the received video data was not affected by this phenomenon.

Figure 9-12—Oscilloscope display photographs of AVCS video data.

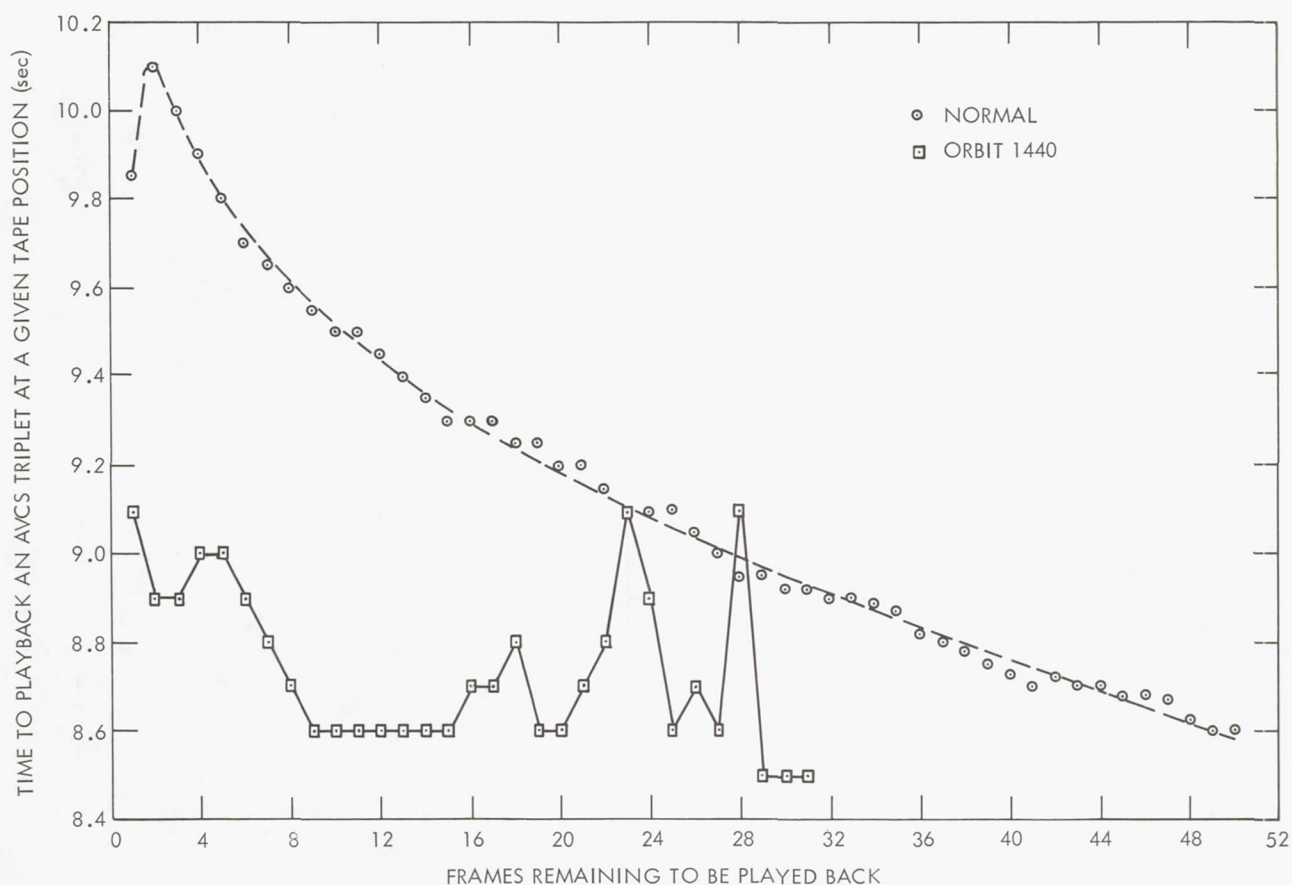
Information contained in the AVCS pregridding program revealed that erratic movement of the AVCS recorder tape first began during orbit 1440 and continued until the time of failure. Figure 9-13 is graphic representation of normal characteristics and the erratic characteristics first exhibited during orbit 1440. The erratic time between the reception of the video triplets and the subsequent recorder failure can probably be attributed to increased friction in the tape reel bearings, increased motor bearing friction, or a change in the characteristics of (or failure of) the negator spring.

Figure 9-13—Time to play back given AVCS triplets as a function of the number of photograph frames remaining to be played back.

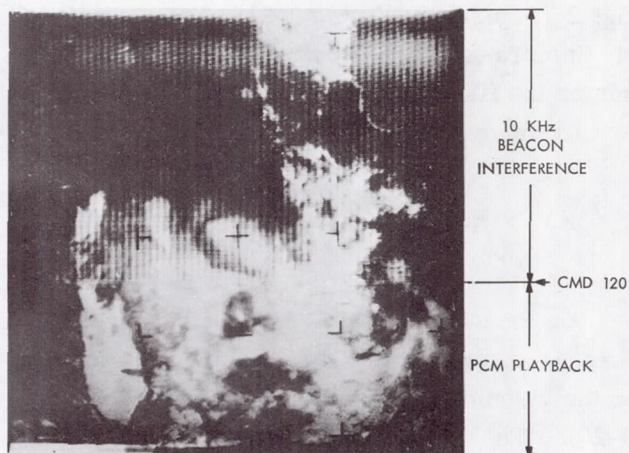
Since the failure of the PCM Subsystem tape recorder, AVCS pictures ranging from good to excellent have been obtained by commanding the PCM Subsystem tape recorder into playback. With the PCM tape recorder inoperative, there was no modulation on the beacon carrier and, therefore, neither 15-kHz nor 10-kHz interference in the pictures. Figure 9-19 illustrates this principle and is typical of the quality of the data received.

Figure 9-19—AVCS (orbit 4399) photograph showing transition from 10-kHz Beacon interference to period of interference-free data during PCM playback mode.

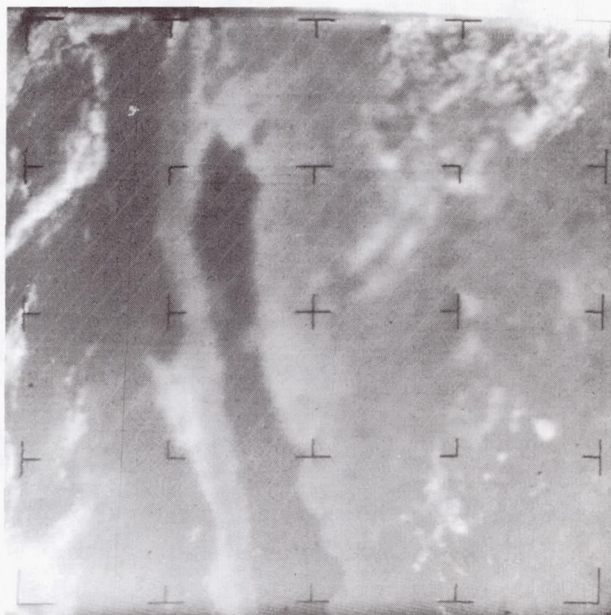
Figure 9-20—AVCS camera no. 1 photograph showing high-voltage chopper interference.

Microphonics of approximately 3.5 kHz sometimes appeared on the video of Cameras 1 and 2 (Figures 9-20 and 9-21). The magnitude of Camera-2 microphonics increased slightly during the first year in orbit while that of Camera 1 remained free of microphonic interference.

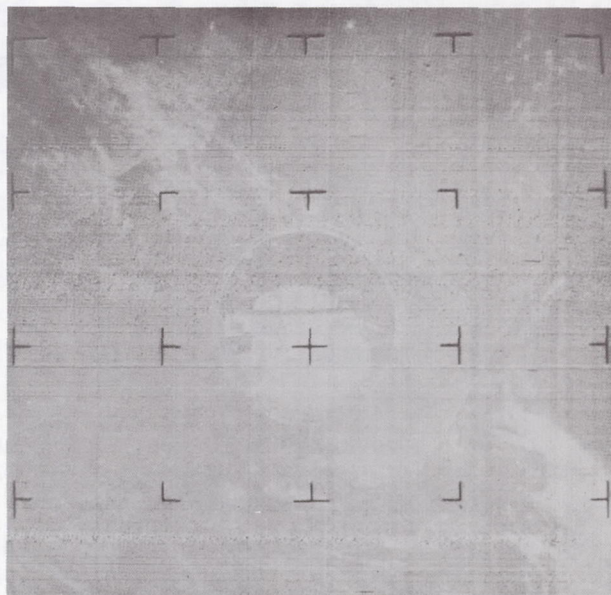
The APT Subsystem camera shutter was triggered immediately following separation by a voltage transient, recording a picture of the adapter and the forward bulkhead of the Agena (Figure 10-3).

Figure 10-3—APT photograph of Nimbus II adapter 2.2 seconds after separation. (Circular adapter is seen as "shadow" in center of photograph.)

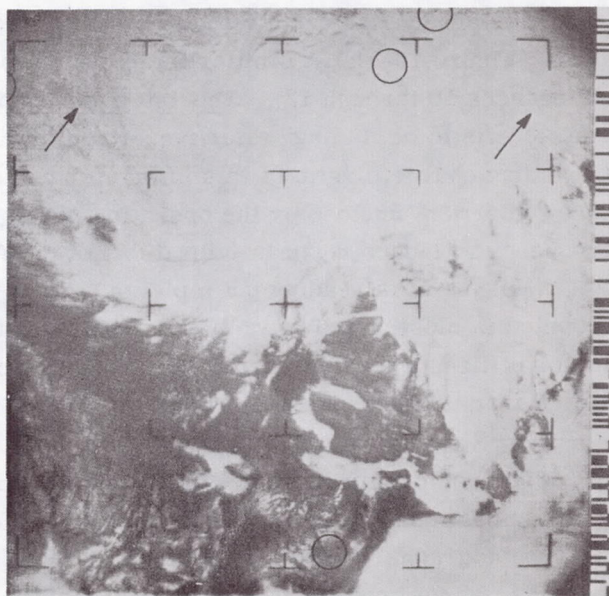
Belmish spotting and dark scan lines resulting from imperfections within the photoconductor or insulator layer of the subsystem vidicon have been continuously present in the APT video (Figure 10-5). The magnitude of the imperfections has increased slightly after launch but not enough to seriously impair the video content of the APT photographs.

Figure 10-5—APT subsystem photograph showing vidicon blemish spotting (circles) and dark scan-line (arrows) imperfections.
